Analysis of the Ways to Identify Rail Running Surface Defects by Means of Vibration Signals

Summary

The article discusses a preliminary concept of a method enabling the identification of chosen rail running surface defects, such as squats, spalling, and running surface defects, by analysing the parameters of vibration signals. It features a description of the methodology of the conducted tests, the scope thereof, and the selection of the measurement points with specific defect types. The article covers selected results of vibration tests, the results of analyses of recorded signals for defective track sections and those for control track sections. The presented measurement results have been obtained for the technical–operating conditions occurring on railway line no. 213 Reda – Hel and line no. 131 Chorzów Batory – Tczew. The preliminary test results and conclusions included in the article show that it is reasonable to pursue further research into the phenomena involving the utilisation of vibroacoustics in rail performance diagnostics.

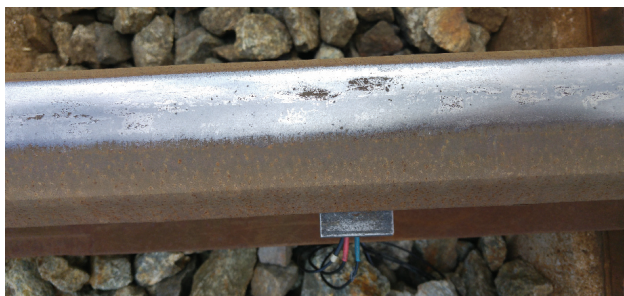
Fig. 2. Spalling defect on railway line no. 213 Reda – Hel [authors' own work]

The next defect is spalling, defect no. 2252 and no. 2251, single and multiple spalling in accordance with PLK's Catalogue of Rail Defects (Fig. 2). Spalling involves the damage of rail running surfaces resulting entirely from the standard use and operation of rails, found commonly on track sections where trains brake violently or where heavy freight trains are accelerated to operational speed. Spalling occurs most often before home signals as well as before level crossings and turnouts.

Spalling occurs symmetrically on both isolated rail sections and is identified by means of visual inspection. Recommended measures to be taken are observation, grinding, replacement or immediate replacement of the rail [3, 7].
