# Influence of Laboratory Ageing on the Preservation of Anti-graffiti Properties for Paint Systems Used in Rolling Stock

The article describes and presents the influence of selected ageing mechanisms of paint systems currently used in railways in Poland in the context of maintaining their original protective properties against graffiti. Six paint systems with different types of finish, which had anti-graffiti properties, were tested, and the characteristics of the surface of the paint system, such as gloss and colour, were determined after a series of painting and cleaning of graffiti (markers and sprays). The tested objects were subjected to artificial simulated ageing using laboratory solar radiation in a synergistic combination of temperature and humidity in accordance with PN-EN ISO 16474-2 and in accordance with the proprietary methodology described in DN 001/08/A2/16 section 4.1.8 using the UV-C radiation source (discrete spectrum). The tested samples were also subjected to a different type of ageing mechanism under strong corrosive conditions in the form of neutral salt spray according to the methodology described in PN-EN ISO 9227.

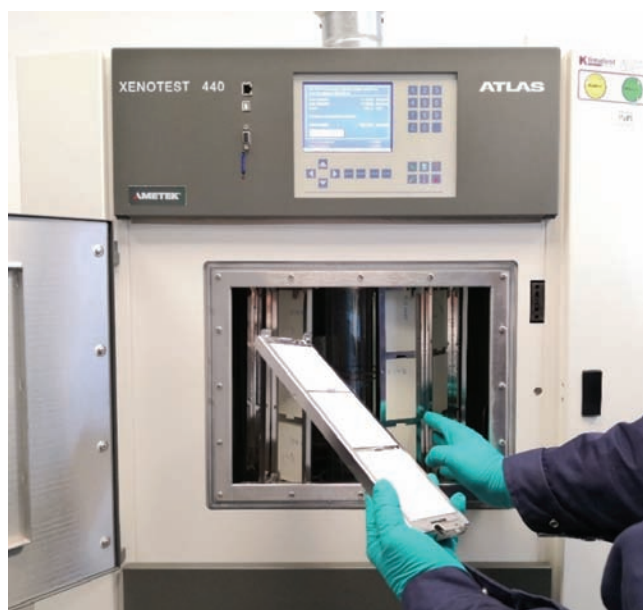
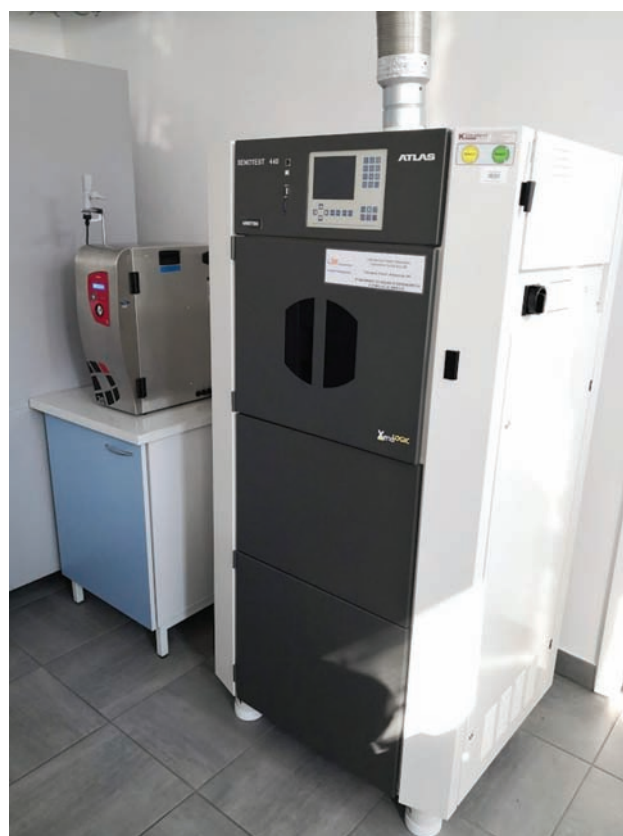
Fig. 1. Test stand for ageing samples according to ISO 16474-2 [7] (xenon weathering instrument, Atlas GmbH Xenotest 440) [Pic. M. Garbacz]

Pictures of the sample ageing test stands where the tests were carried out and an example of the graffiti painting are shown in Figures 1–4.

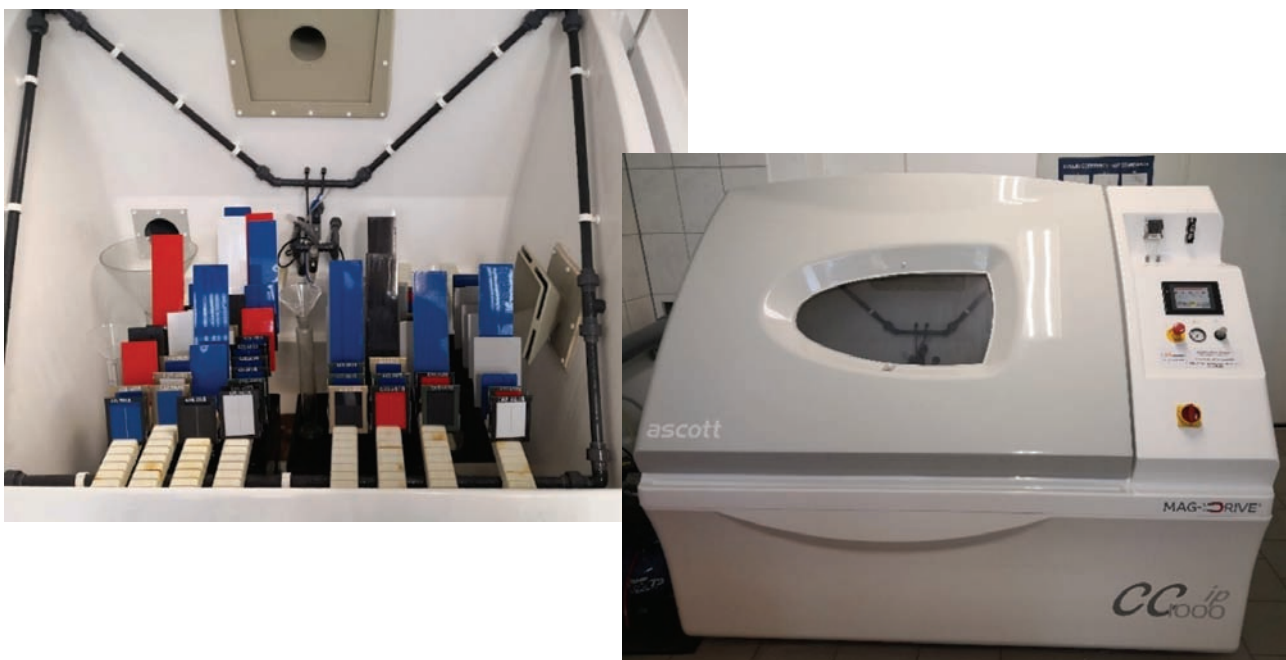
Fig. 3. Test stand for ageing samples according to PN-EN ISO 9227 [12] (Ascott CC1000IP salt spray chamber) [Pic. M. Garbacz]

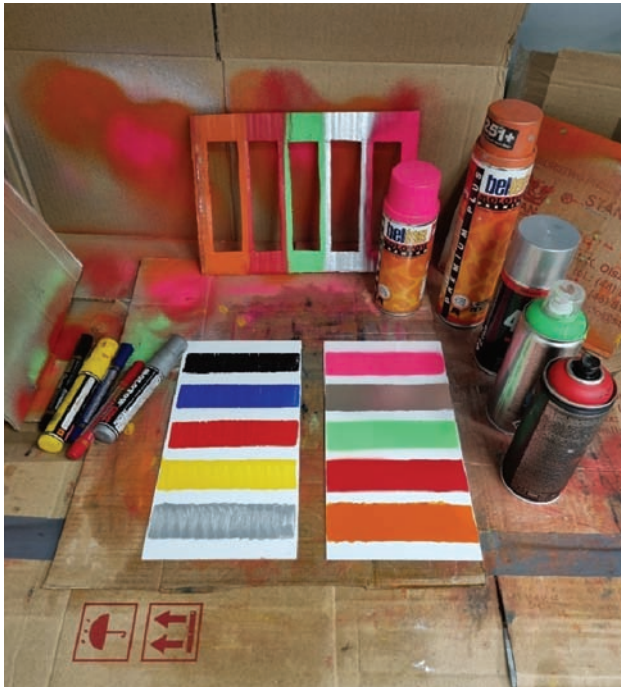
Fig. 4. Test stand for determining graffiti resistance  
[Pic. M. Garbacz]

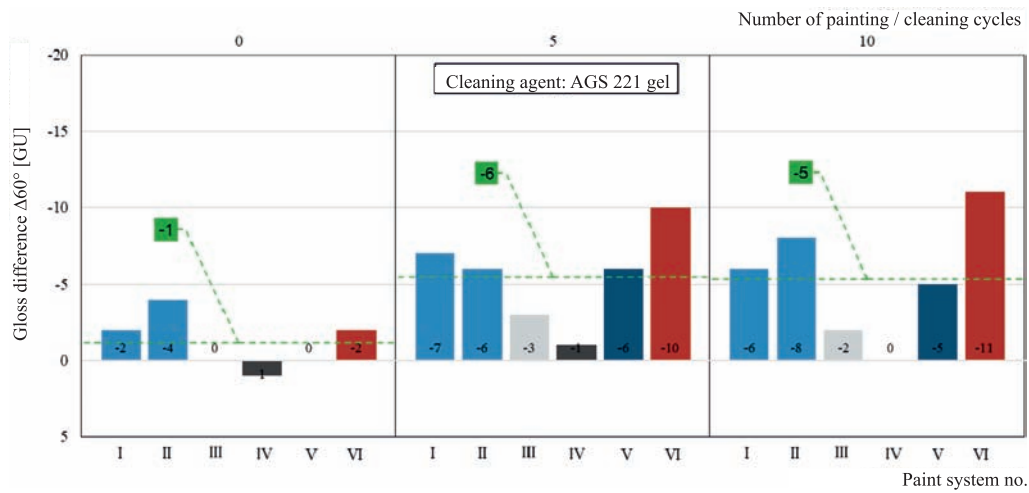
Fig. 8. Change in gloss value in  $60^\circ$  geometry before and after graffiti resistance test after 5 and 10 cycles of painting and cleaning for samples aged according to PN-EN ISO 9227 [12] (AGS-221 remover) [own study]

Figures 5–8 show the changes in the measured gloss values for the 60° geometry, depending on the type of ageing method used and the graffiti remover, while Figures 9–14 show the changes in the measured colour values for  $\Delta E^*$  – CIELAB 1976, depending on the type of ageing method used and the graffiti remover, measured using a sphere spectrophotometer with two measurement modes (with the specular component included and excluded). The results shown in Tables 6 and 7 and in the graphs (Figures 5–14) are the average for the 6 different markings used in the tests carried out (the markings are summarised in Table 2).

Based on the test results shown in Table 6 and Figures 5–8, it is concluded that:

- The salt spray test according to PN-EN ISO 9227 [12] did not significantly deteriorate the protective function of the paint systems against graffiti and is comparable with the results obtained for unaged samples in the evaluation of the change in gloss properties of the coatings. This indicates that the corrosive agent of sodium chloride does not significantly affect the gloss parameter of the coating, even when intense changes in the form of blistering occur (systems II, V, VI). In the case of gloss evaluation according to PN-EN ISO 2813 [19], the decreases in gloss values in the 60° geometry averaged –6 [GU] (5 cycles) and –5 [GU] (10 cycles) for the cleaning agent AGS-221 in gel form.
